Engineering Assessment of Two Cylinders Observed at the Douma Incident**- Executive Summary**

DRAFT FOR INTERNAL REVIEW
Expanded Rev 1 - 27 February 2019

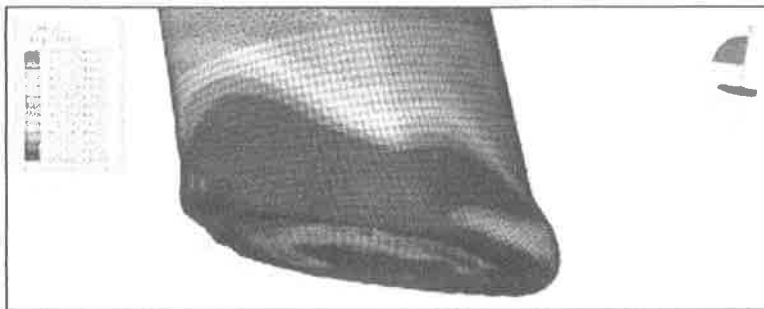
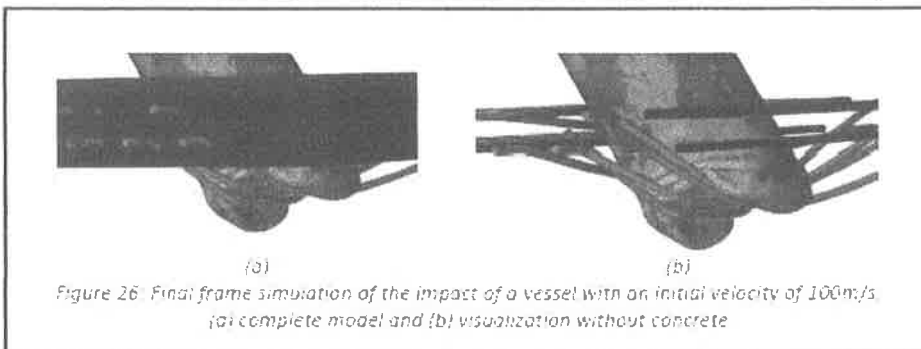
19. Despite these measures, results of these simulations showed that the vessel was again not slowed down to a standstill. Consequently, based on the simulations, the answer to the first basic question was negative. The simulation results thus indicated that the assumed drop heights, even the lowest one of 500m, were too high to be able to reproduce the observed impact event. Further analysis of the simulated and real concrete crater and vessel shape also revealed the following discrepancies:

- In the simulations, steel rebar clearly affected the deformation of the vessel. Indeed, pronounced indents of the steel rebar were obtained. Although, steel rebar was visible in the images of the observed concrete crater, no traces of interaction of the cylinder with the steel rebar were observed on the cylinder.

22. As mentioned above, the predicted cylinder deformation was not consistent with that observed on the cylinder observed at the scene at Location 2. The results predicted from the simulation were more consistent with images of deformed cylinders from earlier incidents of cylinders allegedly delivered from helicopters in the Syrian Arab Republic.

Figures 1 & 2 (above): Predicted deformation; initial and final computational analysis

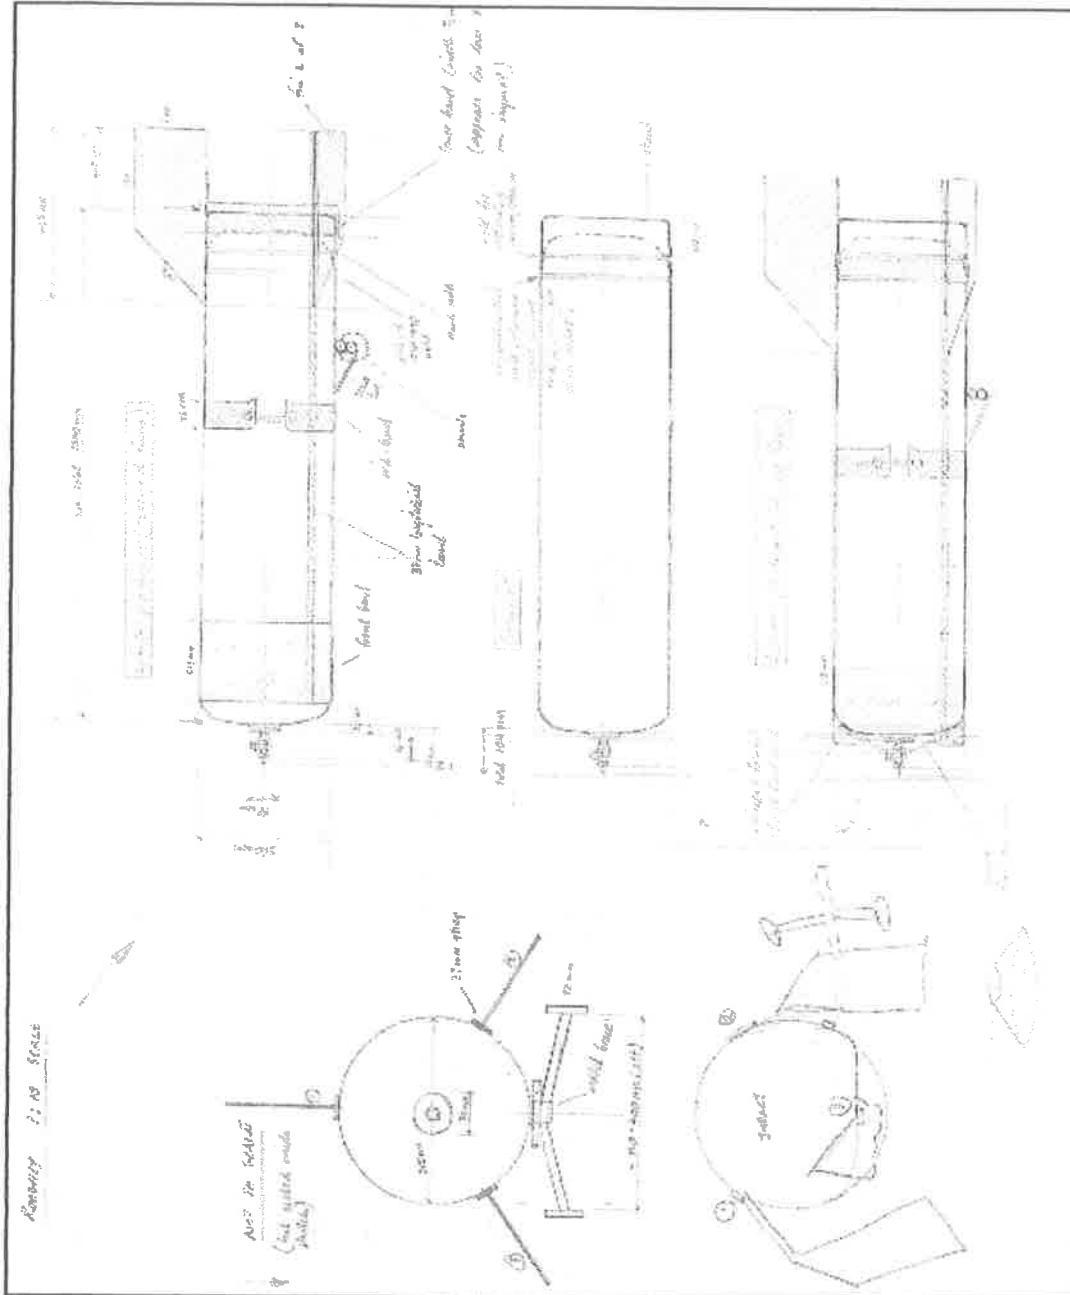
Figure 6: Location 4 cylinder dimensions pre-impact

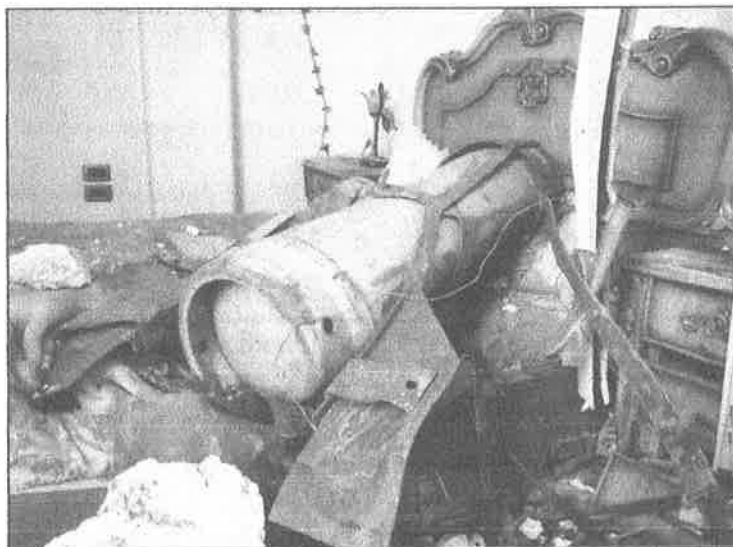
28. Open-source images showed the presence of a truncated conical metal object in the bedroom. By the time the FFM arrived at the scene, this object had been removed. Examination of the front of the cylinder did not show signs of this ever having been attached to the front end of the cylinder, nor of it being stripped off as a result of impact.

29. Examination of the cylinder, including paintwork, condition of the metal surfaces, and the mild steel attachments, indicated a significant degree of degradation (corrosion) as a result of weathering in the areas that had been damaged through impact. Whilst it may be speculative to consider it unlikely that an old, rusty, already-damaged cylinder would be deployed from an aircraft; the cylinder showed appearance of having spent some post-damage time being exposed to the elements, and would most likely not have degraded to such an extent in the case of it being inside the bedroom.

Figure 8: Cylinder at Location 4

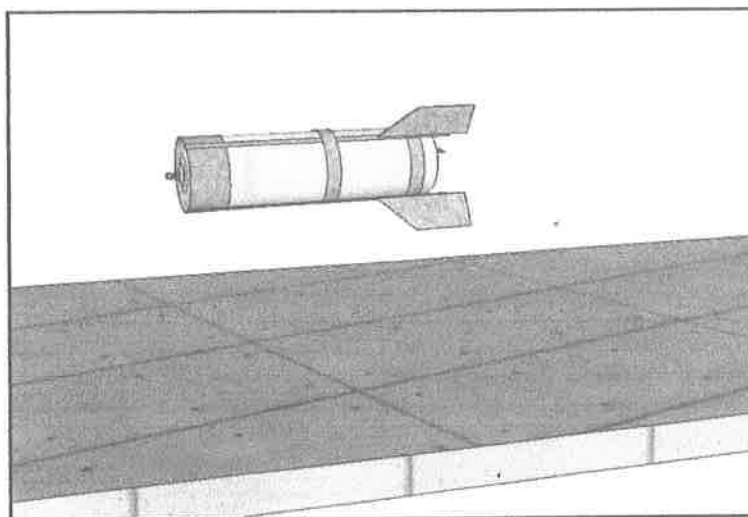
Figure 12: Test case - horizontal angle of incidence

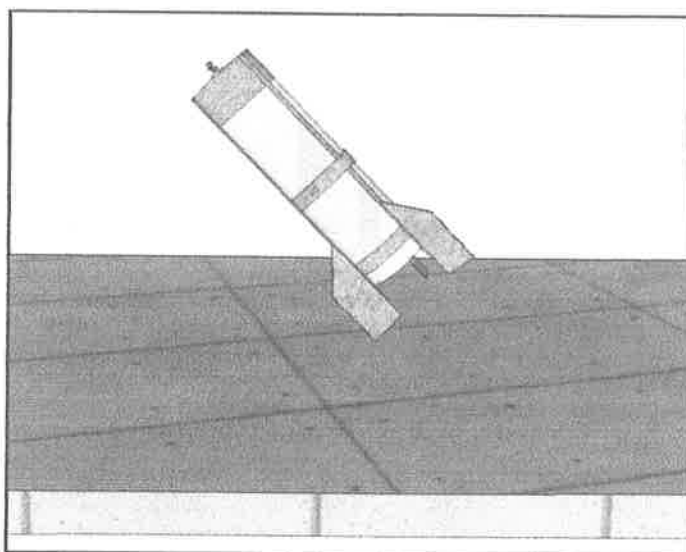
Figure 14: Test case – tail down angle of incidence
