MH17

The Open Source Investigation Three Years Later

Introduction

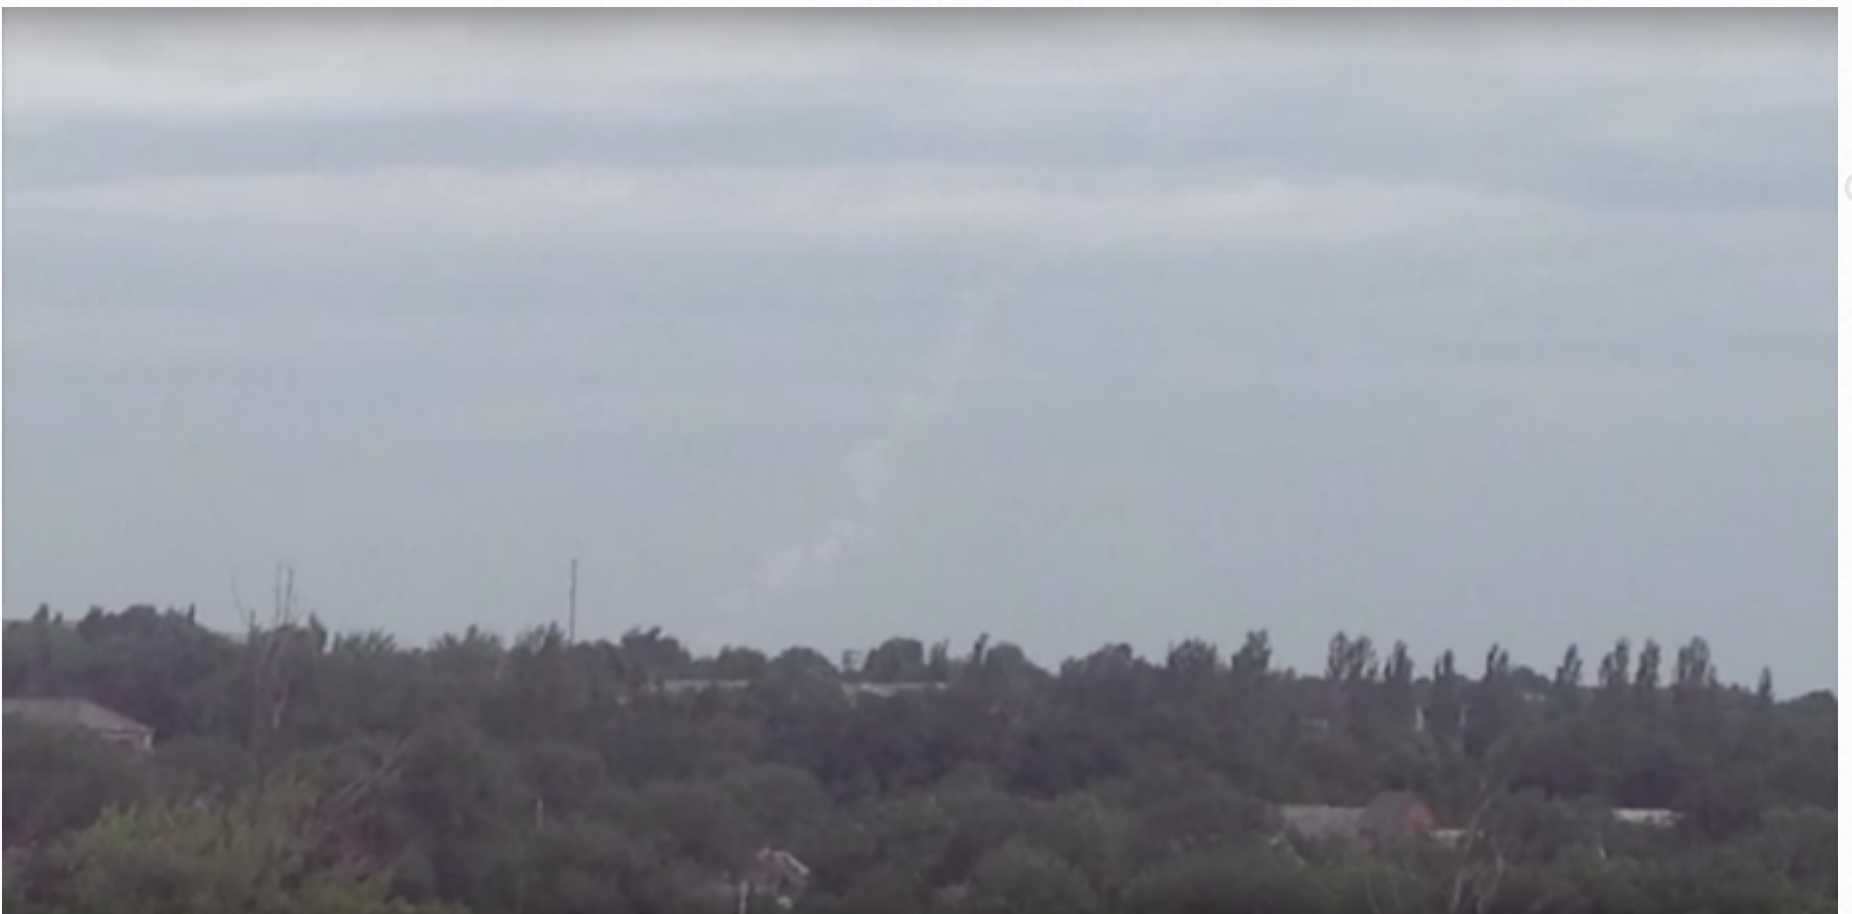
Both the forensic investigation into the downing of MH17, the Dutch Safety Board (DSB), and the criminal investigation, the JIT, have confirmed this assessment, pointing to a field south of Snizhne as the launch location for the Buk missile that downed the plane. At their September 28, 2016 press conference, the JIT published a photograph received from a local witness that had not been previously published. In this photograph, taken from north of the launch location, we see the same smoke trail as in the image shared by @WowihaY.

Buk missile smoke trail shown by the JIT in a press conference

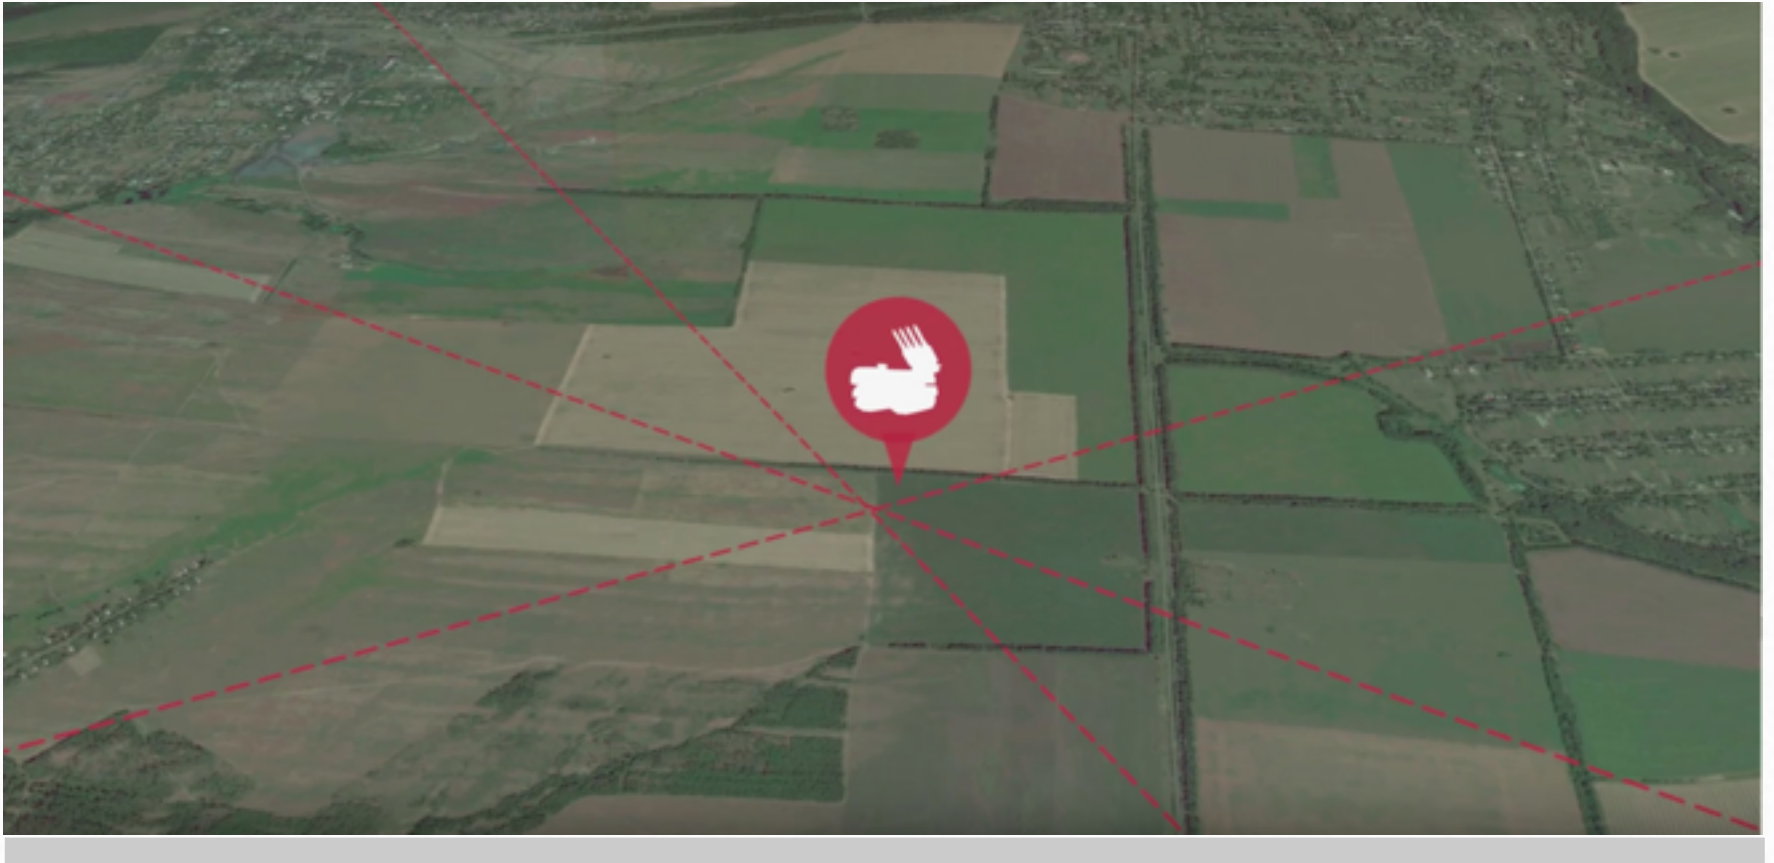
In the same September 28, 2016 press conference, the JIT revealed their calculation of where the missile was launched. Using witness accounts and by determining the sight lines of the two smoke trail photographs, the JIT triangulated the missile launch to a field south of Snizhne and just northeast of the village of Chervonyi Zhovten' at coordinates 47.973906, 38.763963.

Triangulated missile launch site, calculated by the JIT. Lines used in image are not representative of actual evidence

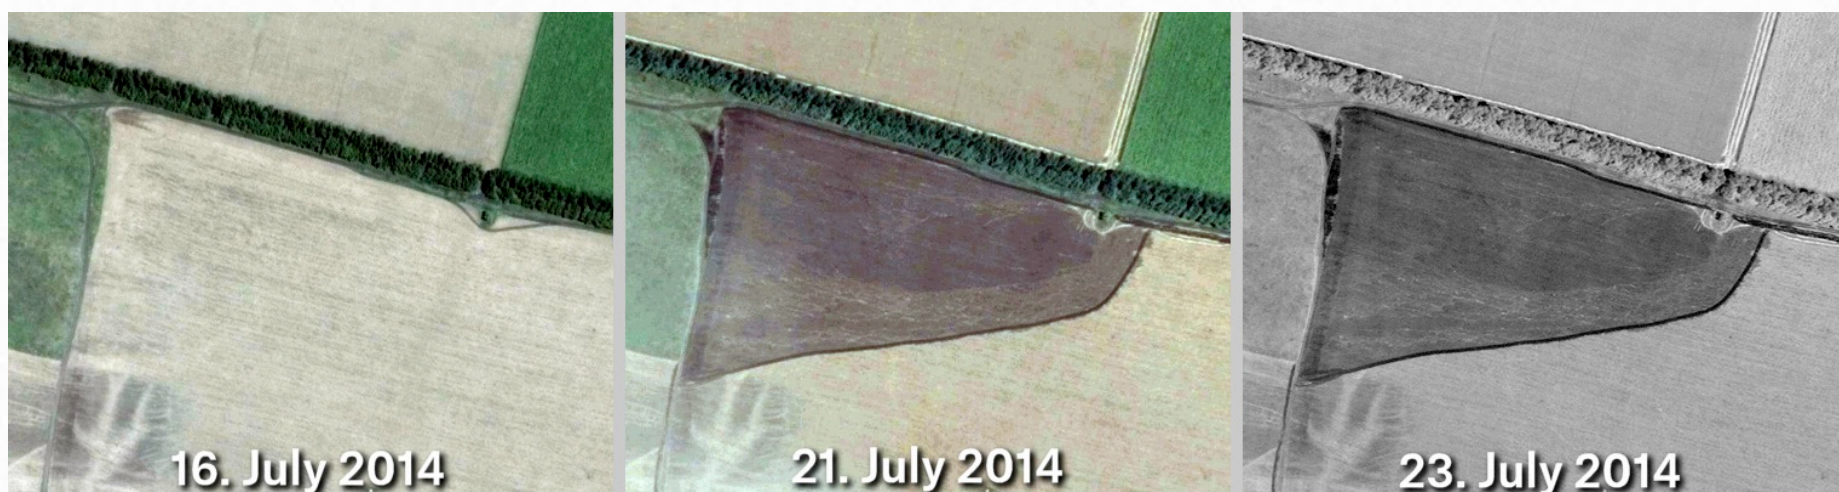
Satellite imagery of the site reveals that between July 16 and 21, 2014 the corner of the field was significantly altered, and new track marks appeared in the area between the dates.

**Field south of Snizhne between July 16 and 23 (Source Google Earth/
Digital Globe)**

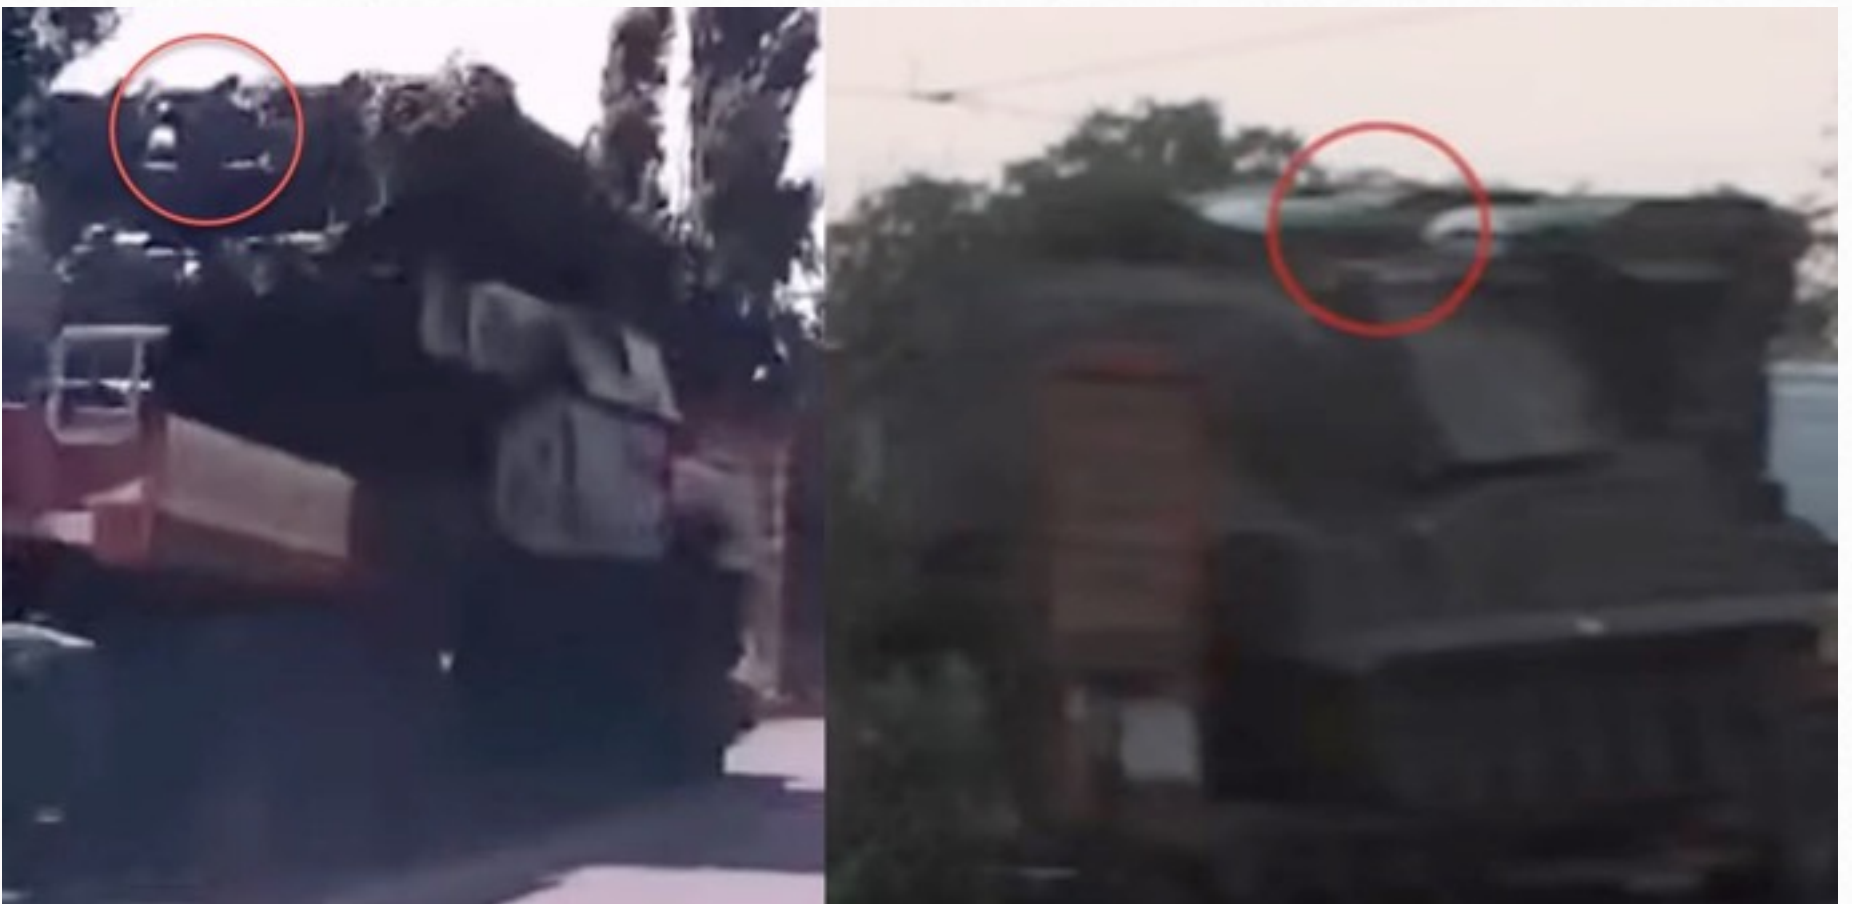
Comparison of Buk 332 in Makiivka on July 17, 2014 (left), with the third missile from the driver's side present, and Buk 332 in Luhansk on July 18, 2014 (right) from the JIT's September 28, 2016 press conference, with the third missile from the driver's side missing

- Buk 332 was next filmed traveling east through the separatist-controlled city of Luhansk on the morning of July 18, 2014 missing one missile. Intercepted communications indicate that the missile launcher was taken into Russia shortly after this video was filmed.

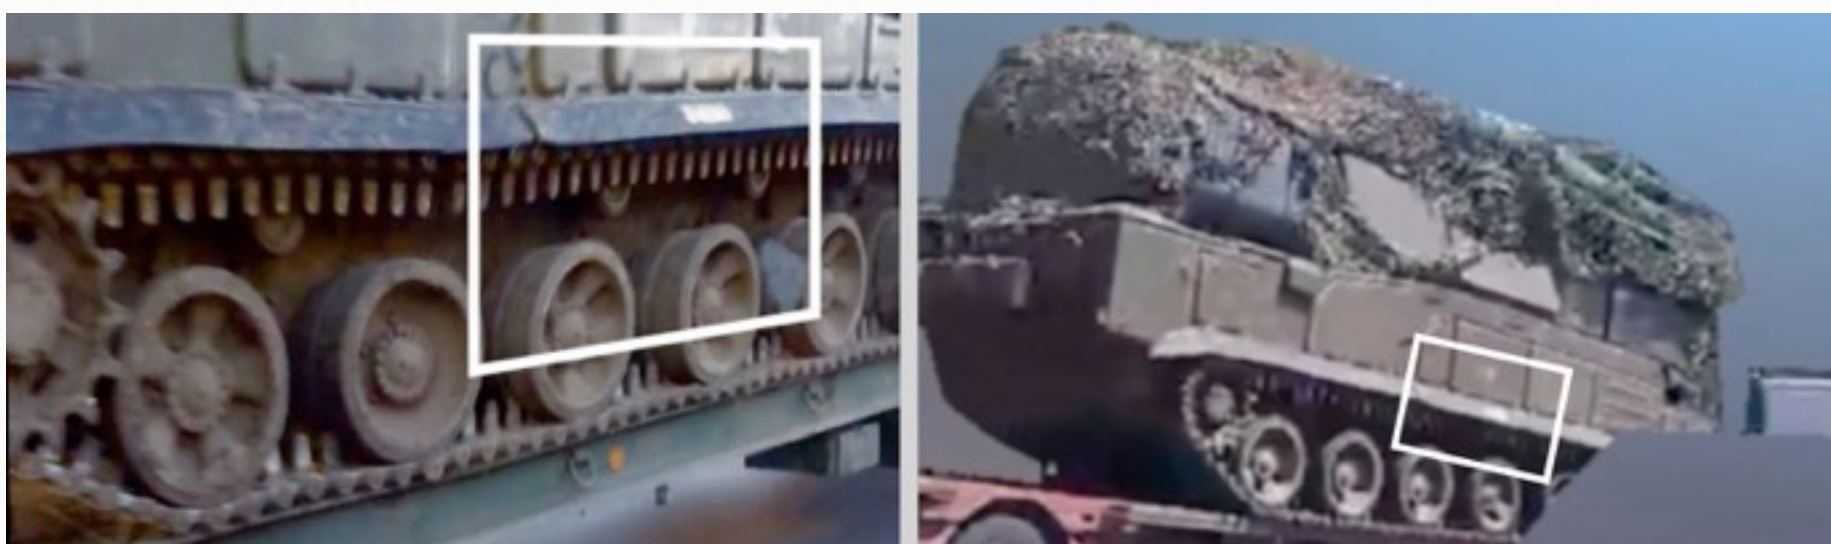
White mark on Buk 332 in Russia in June 2014 (left) and the same white mark on the Buk filmed in Torez from the JIT press conference (right)

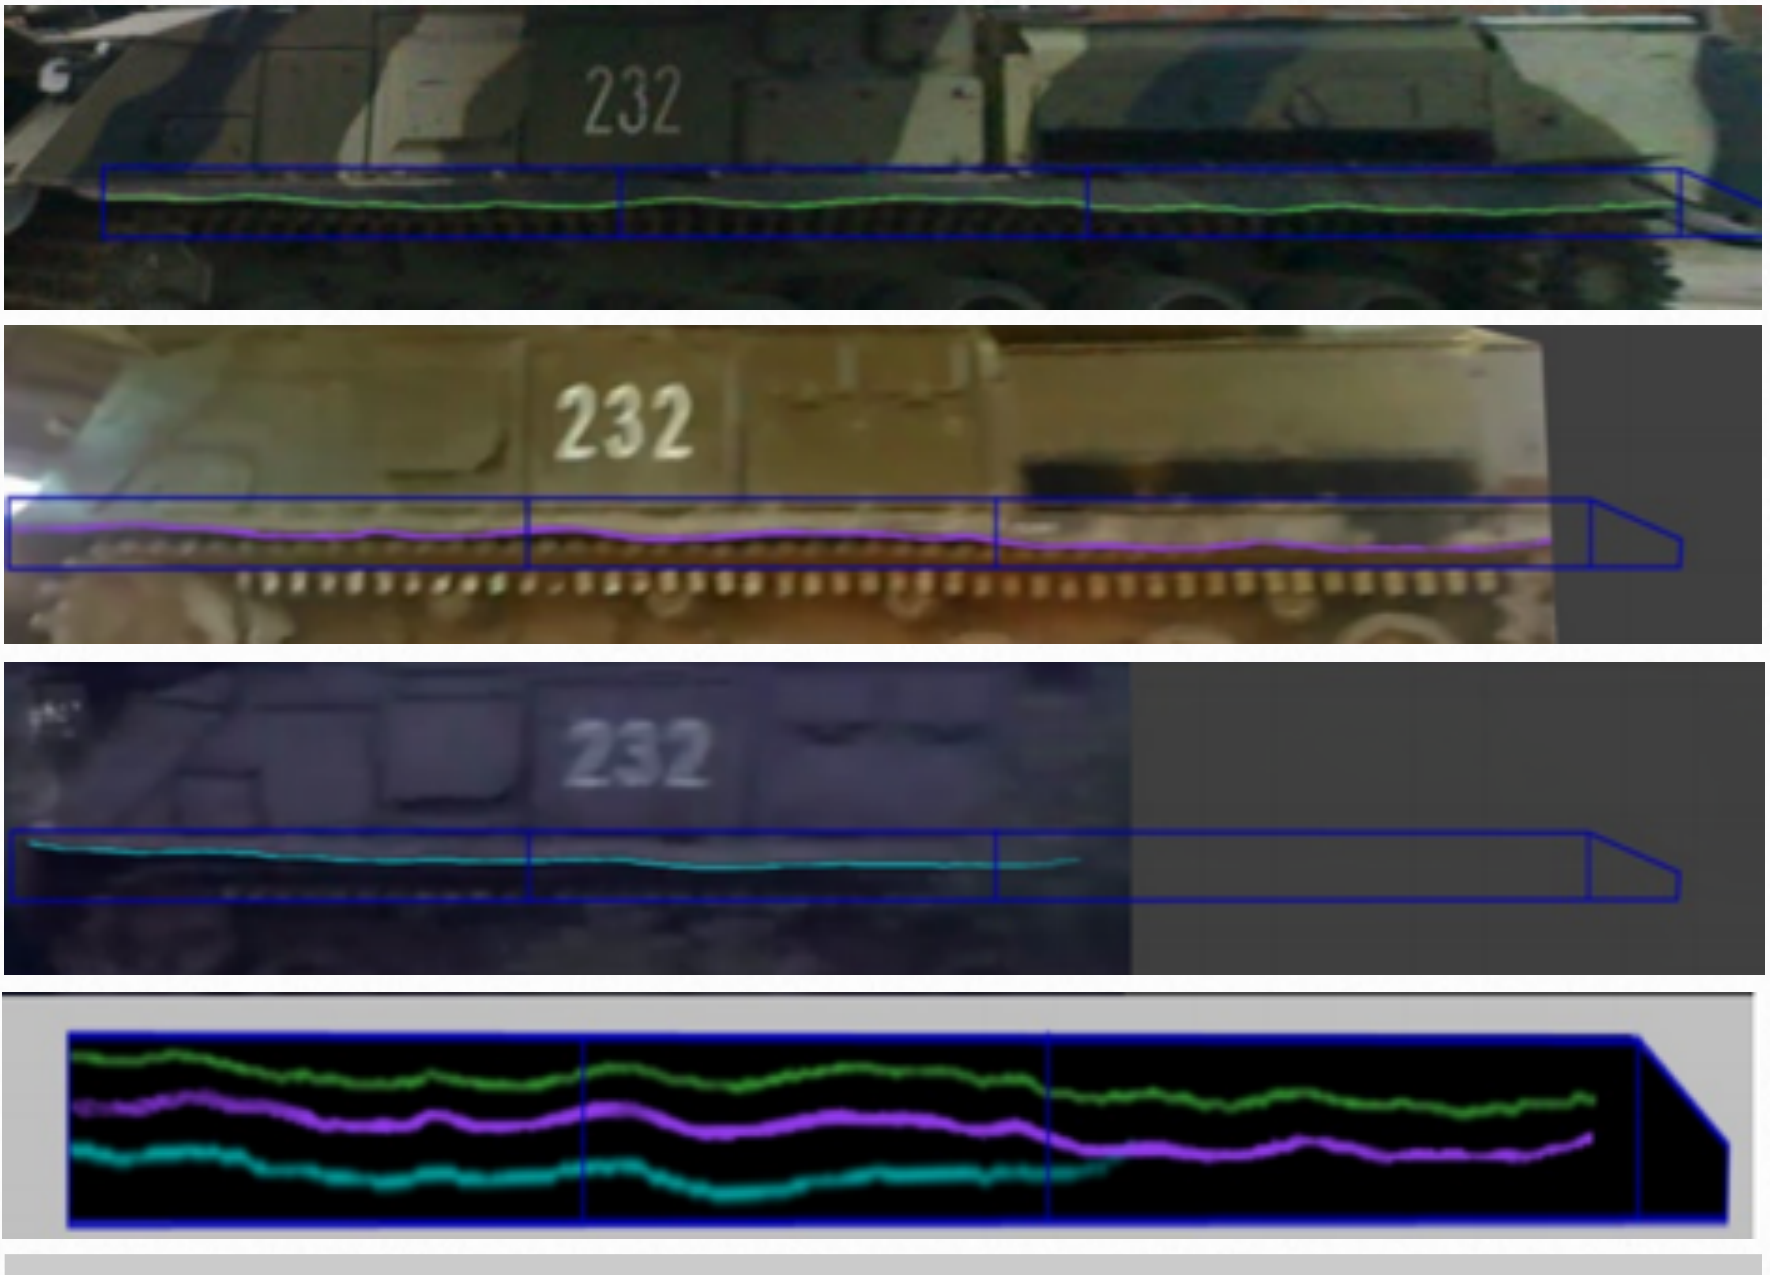
Outside of these details being in the exact same locations on the two Buks, there is an additional, compelling method to compare the “identities” of the Buks. During our research into various Buk sightings, it became clear that the rubber side skirt above the caterpillar track sustains damage over time, creating a unique “fingerprint.” Comparing these side skirt damage patterns, or “fingerprints,” we can identify and match Buk missile launchers with one another. For example, below is a comparison of the side skirt fingerprints of a Russian Buk numbered 232. All three photographs were taken in the same year.

Comparison of the side skirt damage patterns on a Russian Buk with unit designation 232 over the period of a year

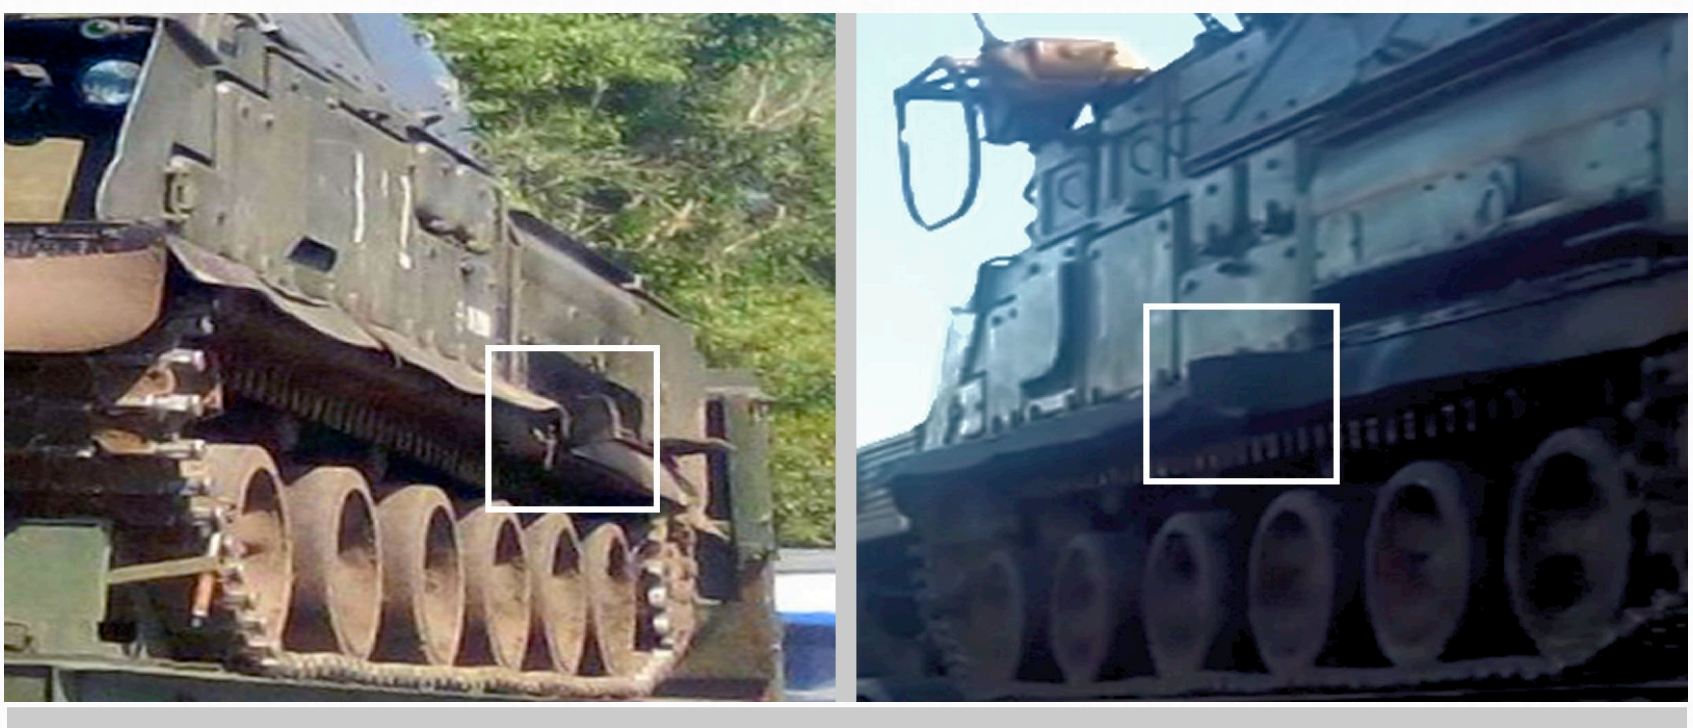
Damage to the side skirt visible on Buk 332 in Russia

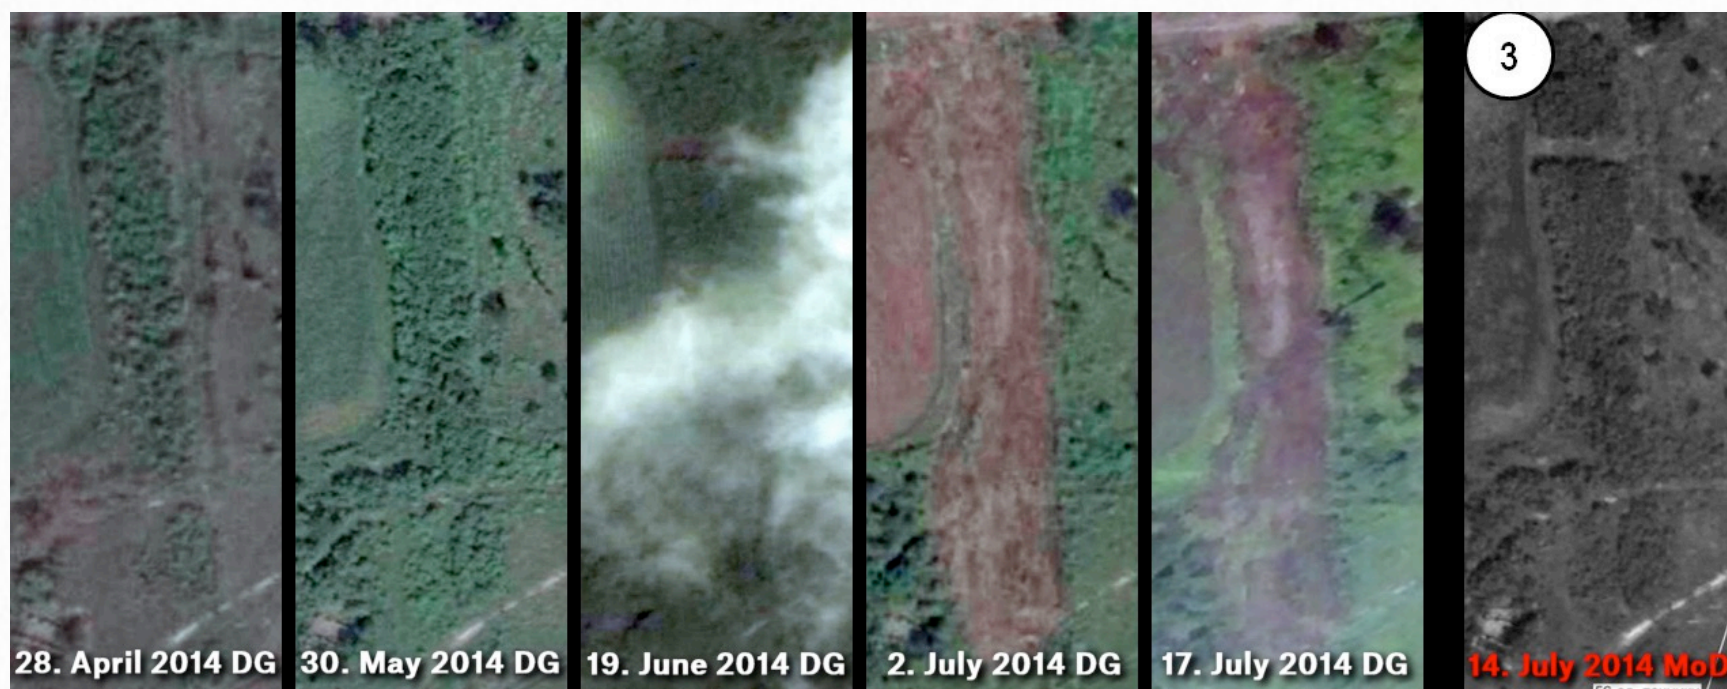
Comparison of vegetation on Digital Globe satellite images, compared to the July 14 image provided by the Russian MoD (far-right)

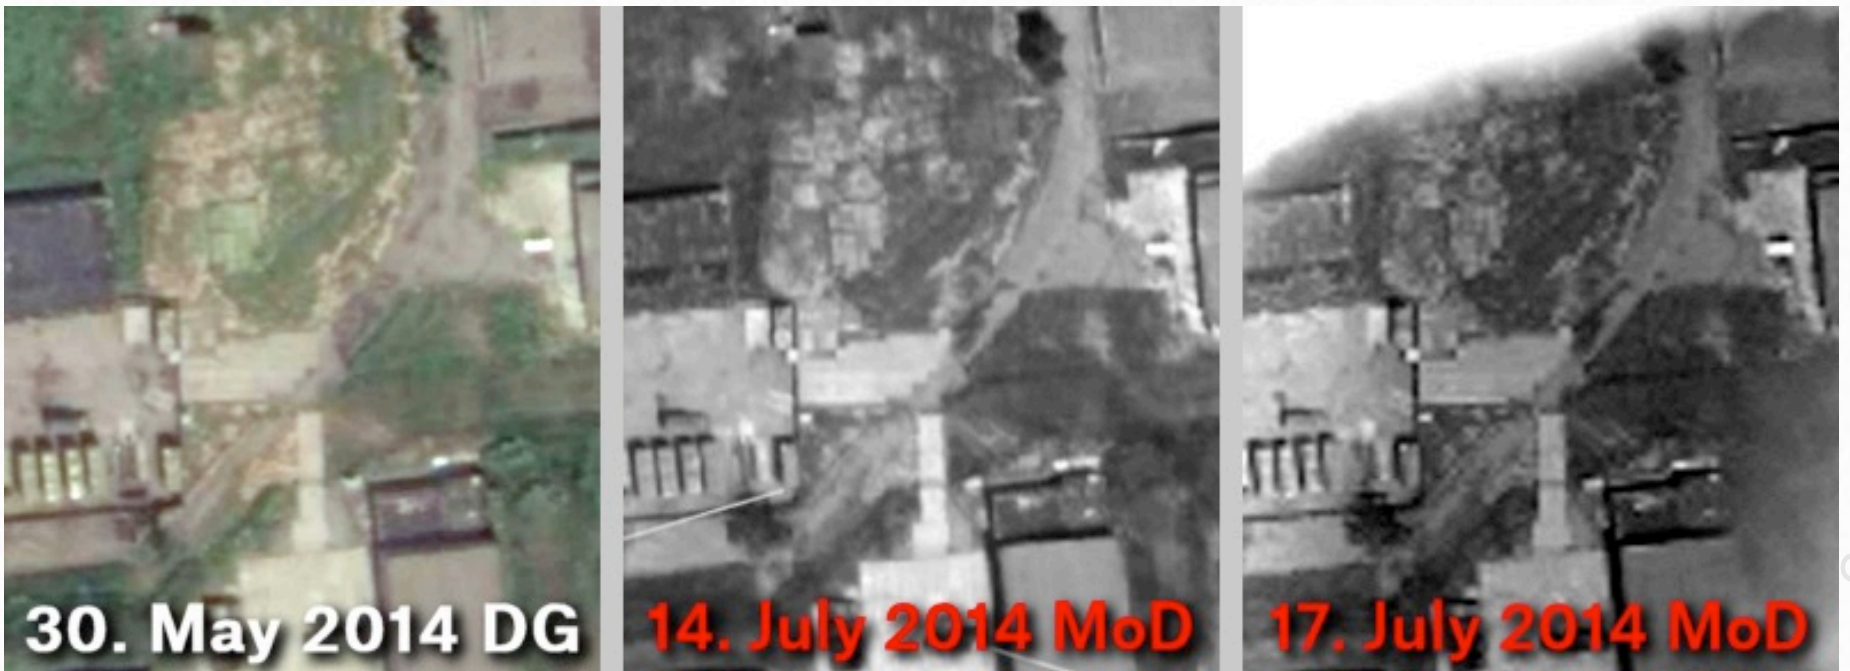
This is not the only discrepancy between the satellite imagery published by the Russian MoD and satellite imagery of the same location freely accessible on Google Earth. There is also an area where patches of grass were worn away in May 2014, but regrew by July 17. In the Russian MoD satellite imagery supposedly taken on July 14 and 17, this area strongly resembles satellite imagery taken on May 30, and looks nothing like that of July 17.

Comparison of satellite imagery from Digital Globe of May 30, 2014 with the July 14 and 17 imagery published by the Russian MoD

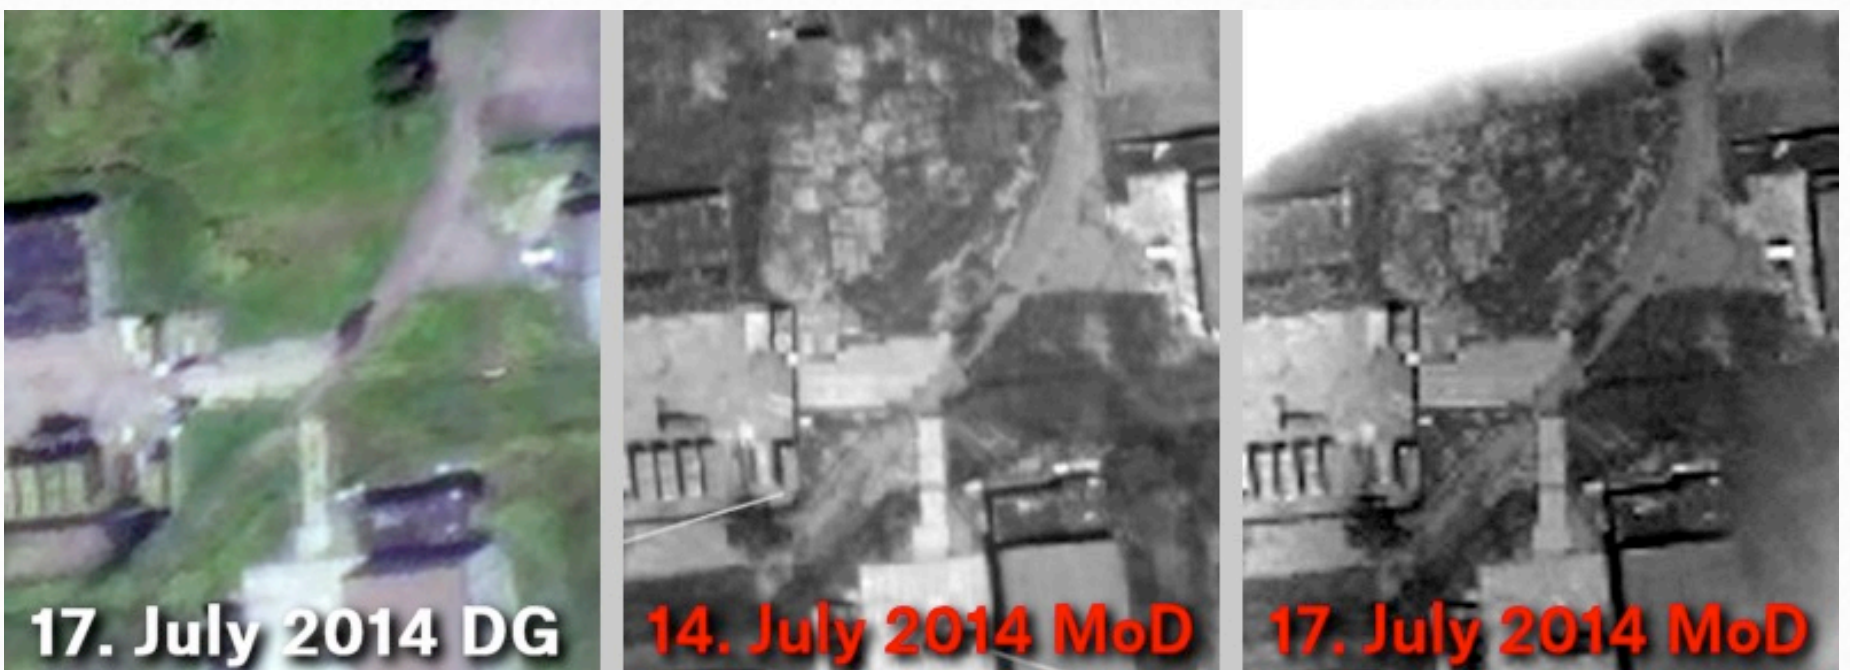
Comparison of satellite imagery from Digital Globe of July 17, 2014 with the July 14 and 17 imagery published by the Russian MoD

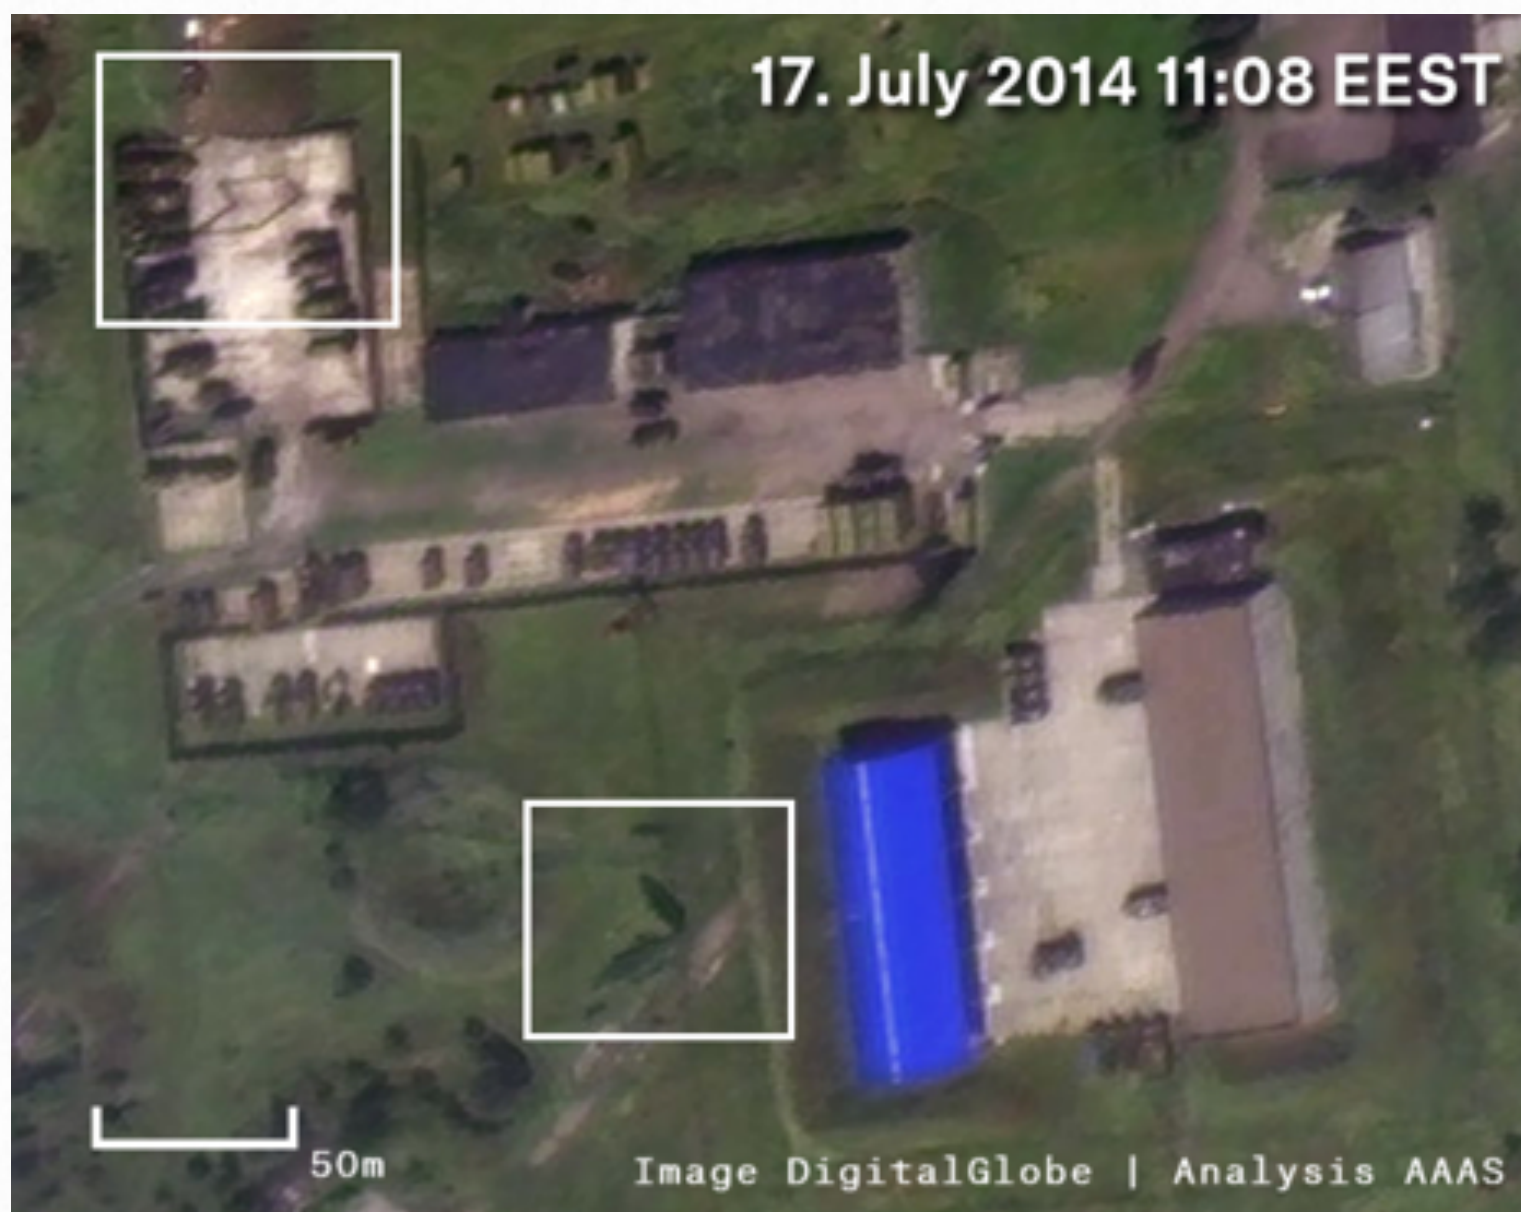
In Spring 2016 Bellingcat contacted the Geospatial Technologies Project at the American Association for the Advancement of Science (AAAS) with a request to independently review the satellite images provided by the Russian MoD on July 21, 2014. AAAS tasked two analysts who each independently reviewed these images, and the AAAS responded to Bellingcat with details of their findings. They found that the shadows of two objects (seen below) on the Russian MoD's satellite images do not correspond with the given dates provided by Russia, meaning that either the time, date, or both time and date of the satellite image are incorrect.

Image highlighting the object used to measure solar azimuth
